OVERALL STABILIZATION OF THE MASSA MARTANA'S RAVINE (ITALY) THROUGH THE USE OF HIGH STRENGTH PVA GEOGRIDS AND OTHER GEOSYNTHETICS FOR THE OPTIMISATION OF THE HYDRAULIC REGIME

Abstract: The "Fosso della Rocca" is one of the 3 big flumes around the municipality of Massa Martana located in the province of Perugia (Italy). As a result of progressive erosion problems the cliff near the village became subject to a condition of critical stability.

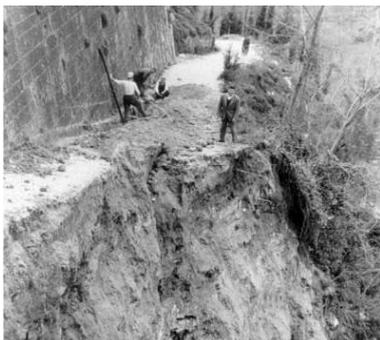
A dormant landslide (Figure 1) is apparent located along the northern retaining wall that confines Massa Martana's village.

Figure 1. Landslide at the toe of the retaining wall bordering the village

This landslide, occurred for the first time in the '60s, it has been reactivated several times in subsequent phases. The landslide body has been partially eroded at the toe due to the water flow of "Fosso della Rocca" stream and, gabions filled with stones have been installed to minimise the erosion through critical zones.

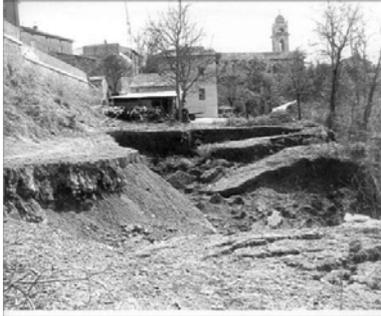
Along the same side, towards the throat of the gully, on 29 March 1981 another significant landslide occurred (Figure 2). The collapse of wall, with rotational and translational movements, brought large quantities of debris down into the gully.

Figure 2. Landslide at the head of the ravine (1981)

The soil displaced during the landslide was formed of blocks of travertine sands mixed with sandy loam and gravel. Behind the wall face, a long step of 50-60 cm in height was present, evidence of deeper sliding surfaces.

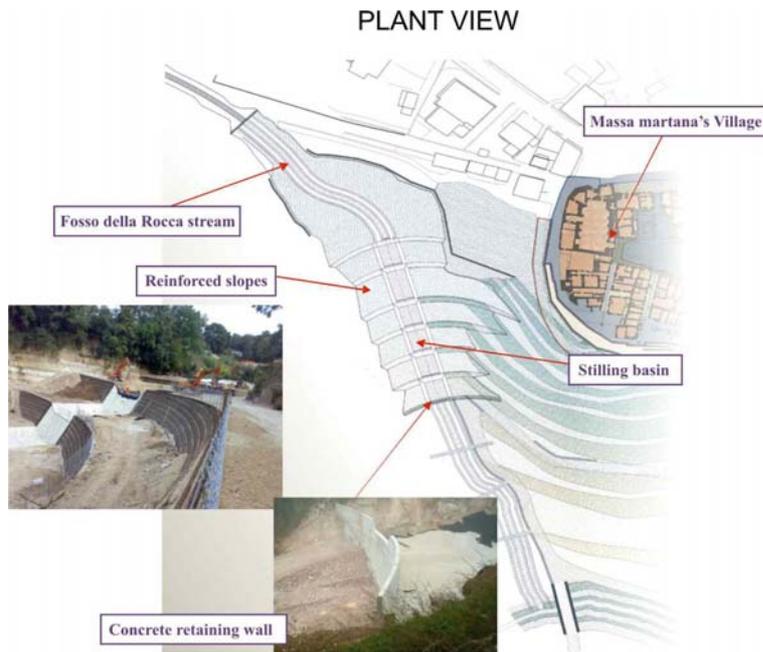
Figure 3. Plant view of the project

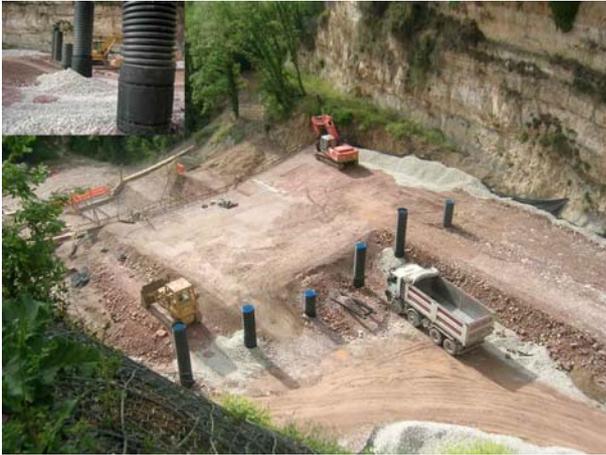
A drainage system to collect and discharge the water coming from springs, from infiltrated rain water and from potential leakage of water coming from the stream was installed within the embankment. The drainage system comprises a sequence of horizontal blankets of gravel (grain size 50-100 mm) interconnected with vertical perforated drainage pipes filled with gravel. Both, mattresses and pipes have been filtered using a geotextile woven filter to avoid the progressive clogging of the gravel. Figure 5 shows the layout of the internal drainage grid.

Figure 5. Vertical pipes interconnecting horizontal drainage blankets, both covered with a woven filter

A woven filter was specified rather than a non woven geotextile because of its high permeability and reduced tendency to clogging, as well as its high resistance to mechanical damage during installation. The technical characteristics of the woven filter are shown in Table 2.

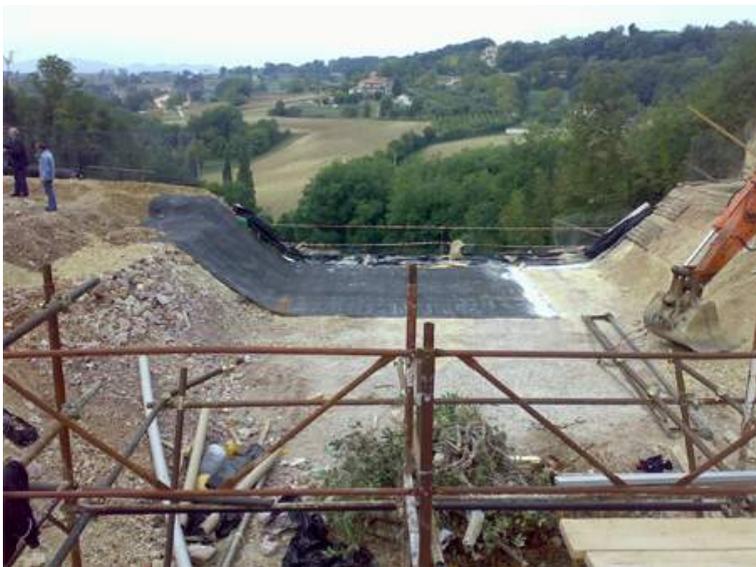
The stream was lined with a GCL to limit direct infiltration of water into the constructed soil mass. The GCL has been confined with 60 cm of soil and, to avoid possible sliding along the channel a special type of GCL with rough surfaces in order to increment the friction with the cover soil was used.

Figure 8. Section of “Fosso della Rocca” stream in the stilling basin. GCL installation

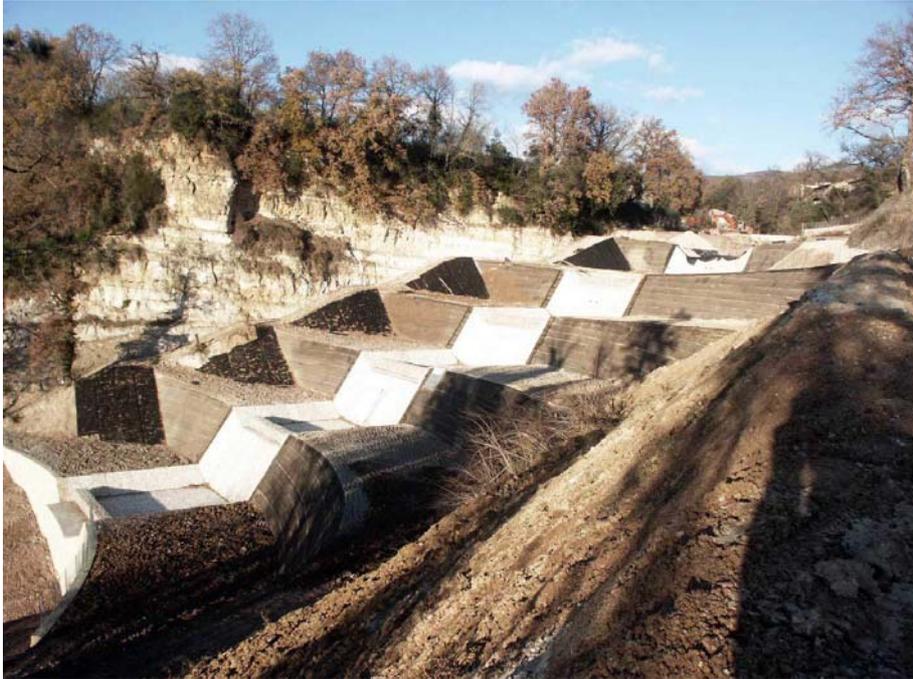
Figure 9. Overall view. Reinforced slopes, central water chute and erosion control geomats on the peripheral slopes

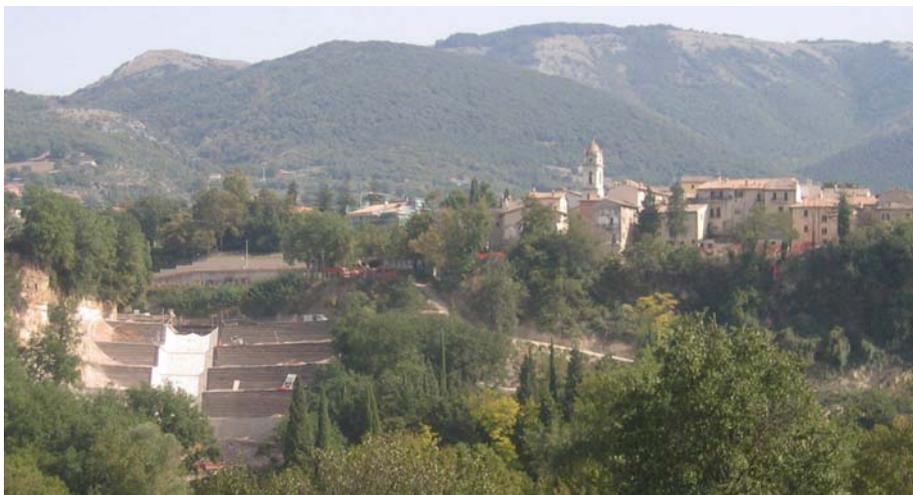
Figure 10. Overall view of the work and Massa Martana village.
